# TELEVISION INSPECTION

Line Segment: (FC09) P18 NE107

Location: FAS NITE PARK

**To:** Lyman, Randy; Dotson, Art; 'pmelgren@ghnae.com'  
**Cc:** Pabst, Gene  
**Subject:** RE: Fassnight Pool Project

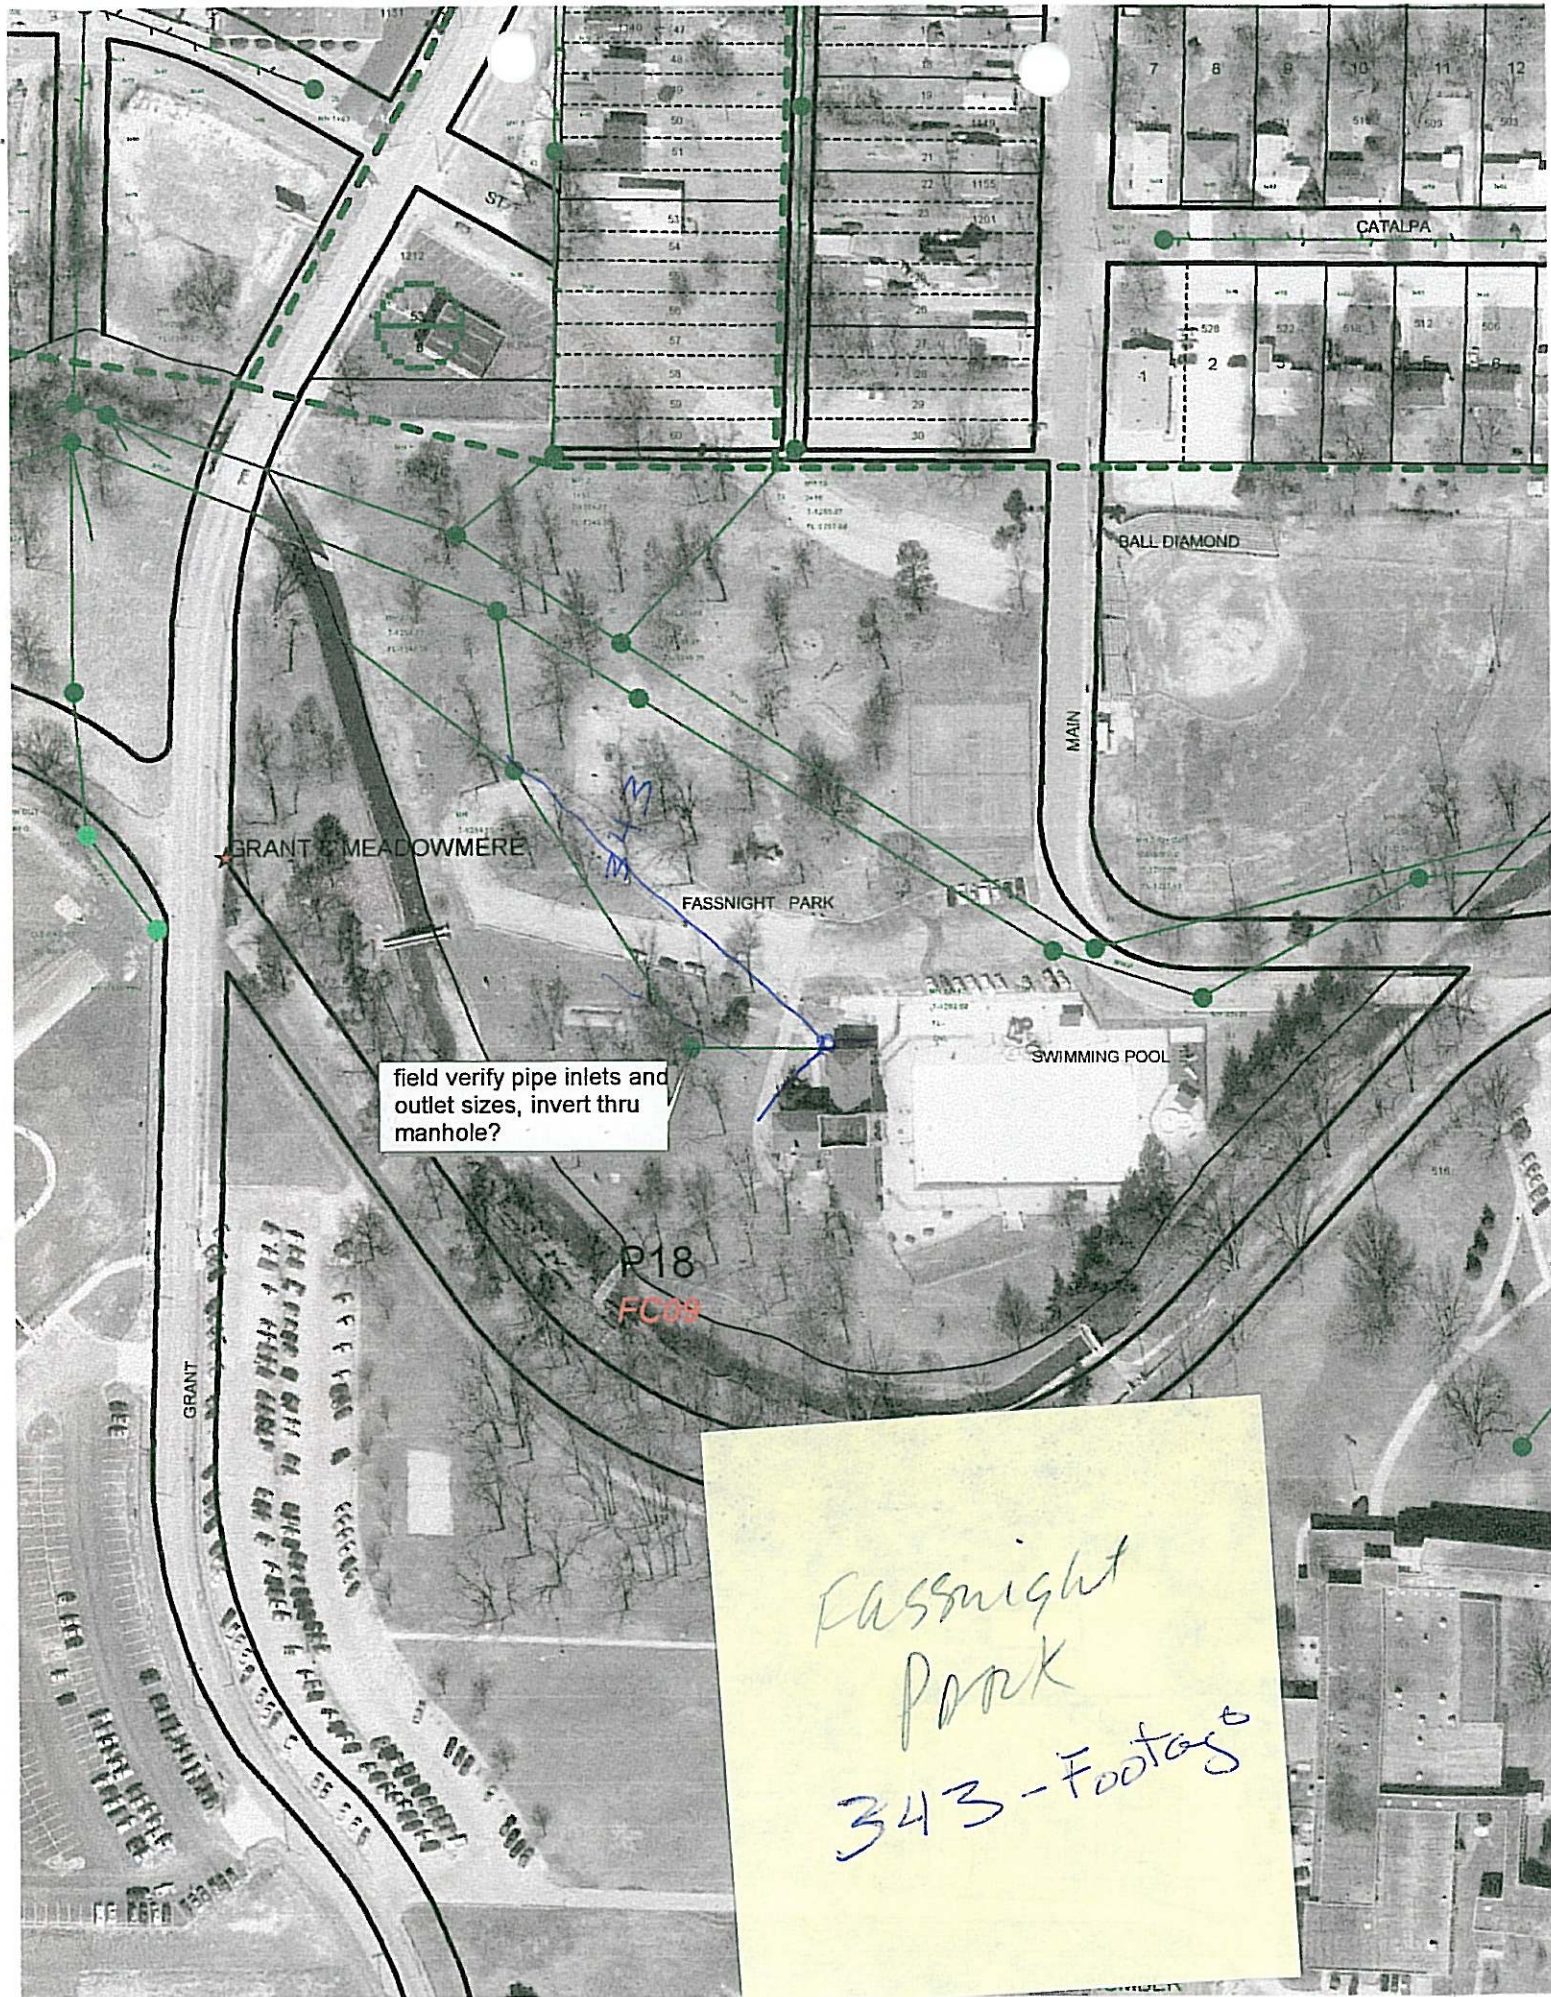
P18  
FC08

field verify pipe inlets and outlet sizes, invert thru manhole?

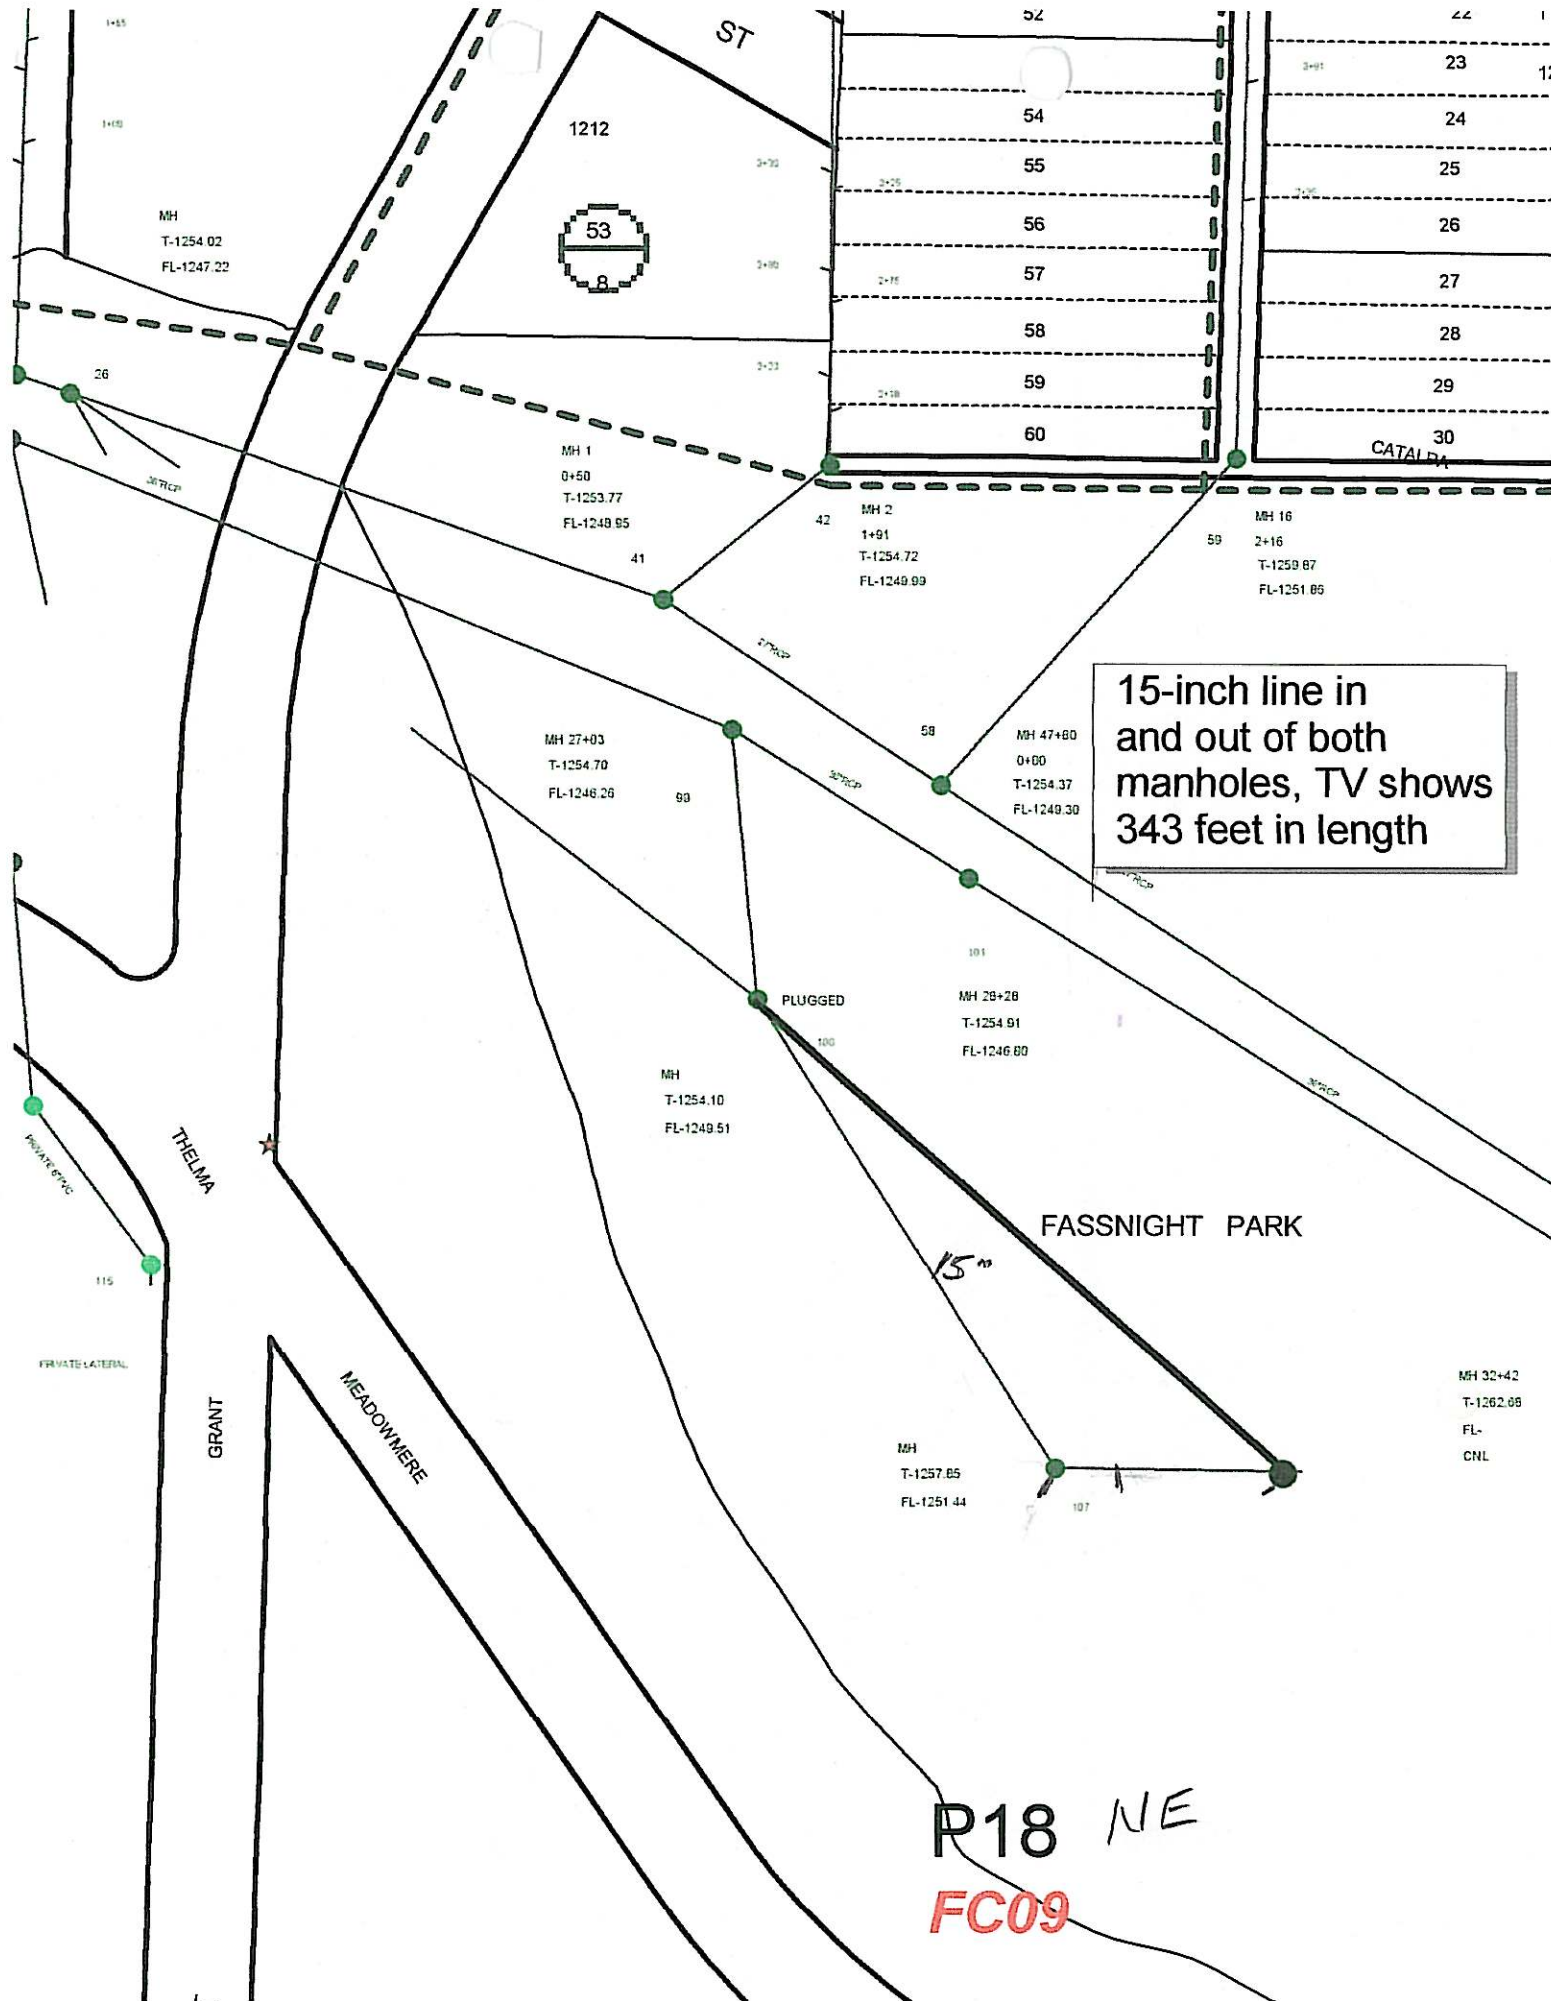
P18 NE  
FC09

15-inch line in and out of both manholes, TV shows 343 feet in length
